# California Department of Fish and Wildlife

## Fisheries Restoration Grant Program

### Restoration Project Case Study

## P1110320 Lindsay Creek Bridge Restoration Project

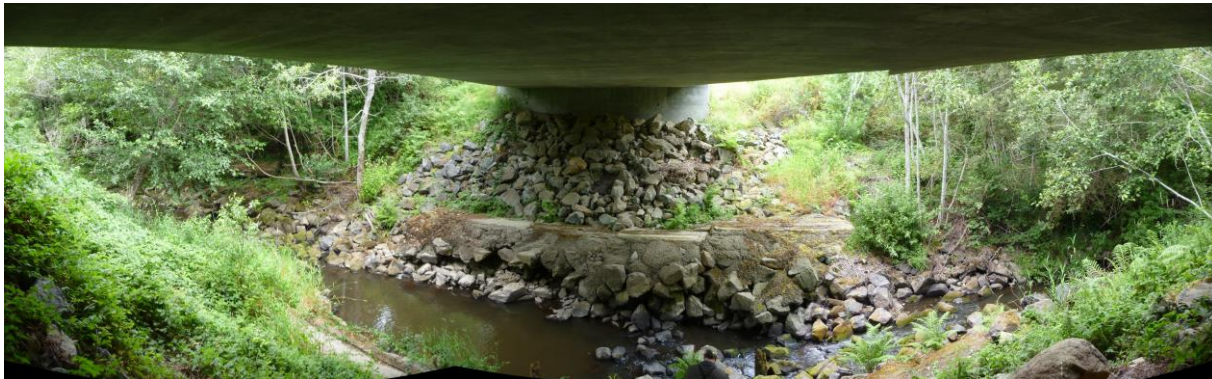
**Figure 1.** Undermined gunite false work and RSP material along right bank and in channel – Pre-treatment condition, 7/23/2013

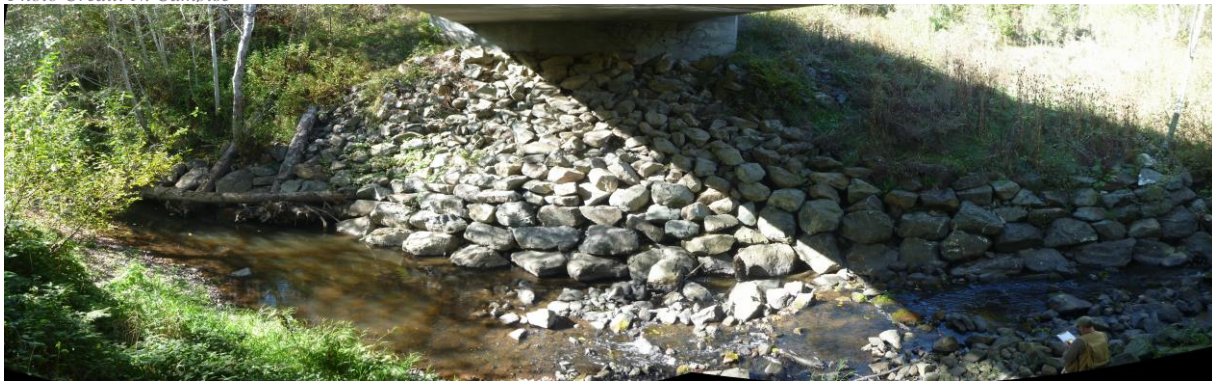
**Figure 2.** Newly placed RSP material and LWD feature placed along right bank – Post-treatment condition, 10/21/2015

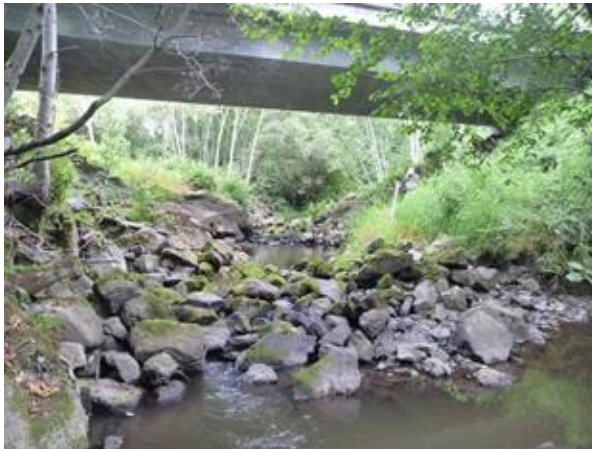
**Figure 3.** RSP partial barrier downstream of bridge – (Pre-treatment condition, 7/23/2013)

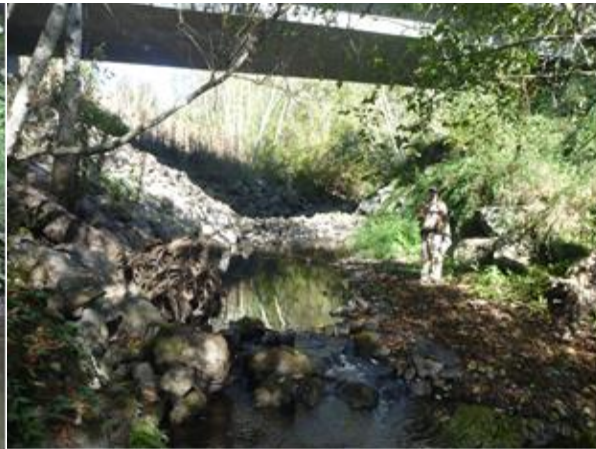
**Figure 4.** RSP removed from channel and LWD feature installed on right bank– (Post-treatment condition, 10/21/2015)
