**California Department of Fish and Wildlife**  
*Fisheries Restoration Grant Program*  
Restoration Project Case Study

**P1410551 Lindsay Creek Coho Habitat Enhancement Project**

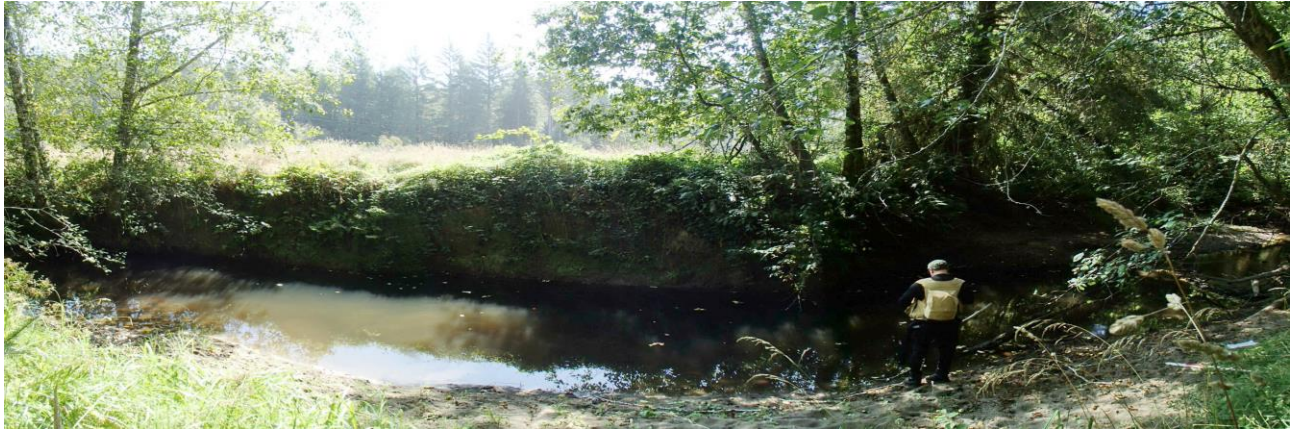
**Figure 1.** Unprotected, erosive bank at proposed site for LW structure placement (Pre-Treatment Condition, 8/18/2016)

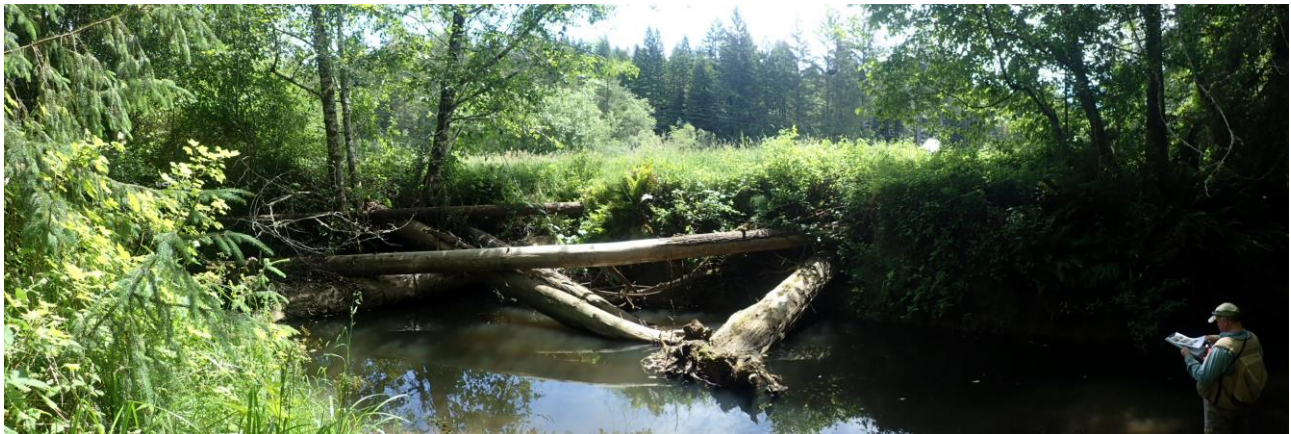
**Figure 2.** Trenched logs helped increase cover, provide high flow refugia, and bank stabilization (Post-Treatment Condition, 6/11/2019)

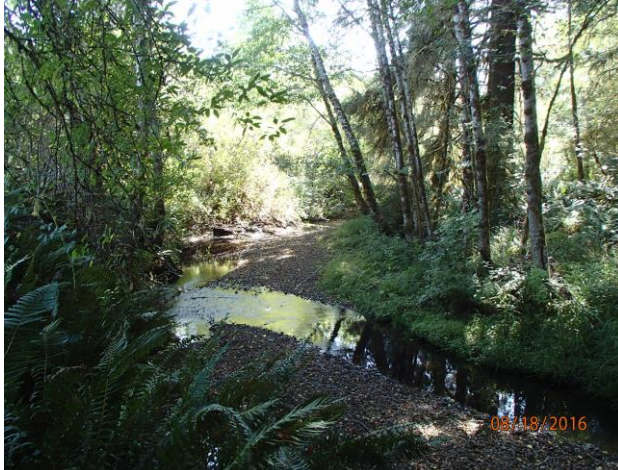
**Figure 3.** Shallow pool on leftbank and channel devoid of large wood (Pre-Treatment Condition, 8/18/2016)

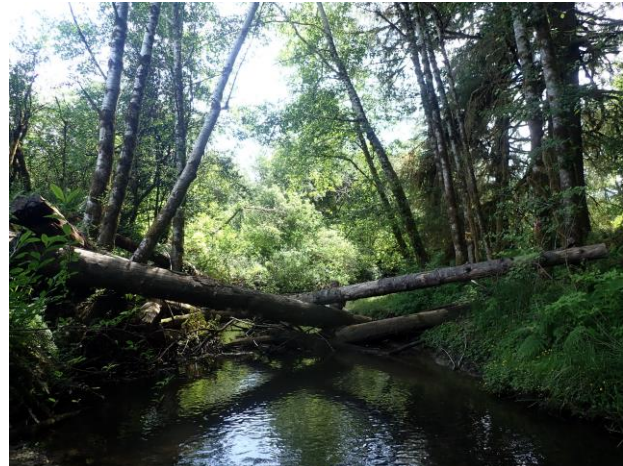
**Figure 4.** Opposing wood woven into existing riparian intercepts small wood and increased depth in existing shallow pool (Post-Treatment Condition, 8/23/2016)
