California Department of Fish and Wildlife
Fisheries Restoration Grant Program
Restoration Project Case Study

**P1510529 Redwood Creek Instream Habitat Improvement Project -
 Schroeder**

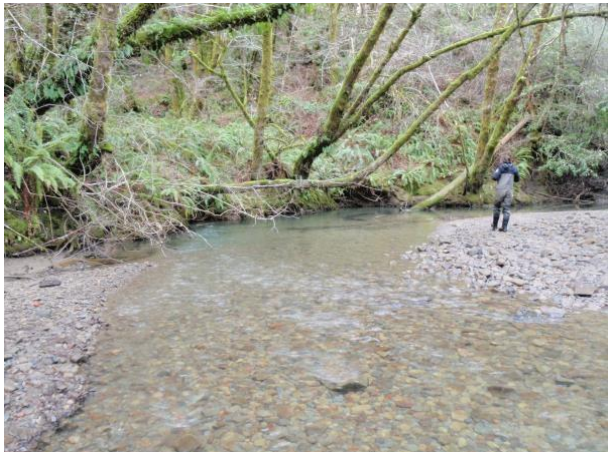
Figure 1. Shallow, lateral scour pool lacking large wood prior to feature placement (Pre-treatment conditions, 9/1/2016)

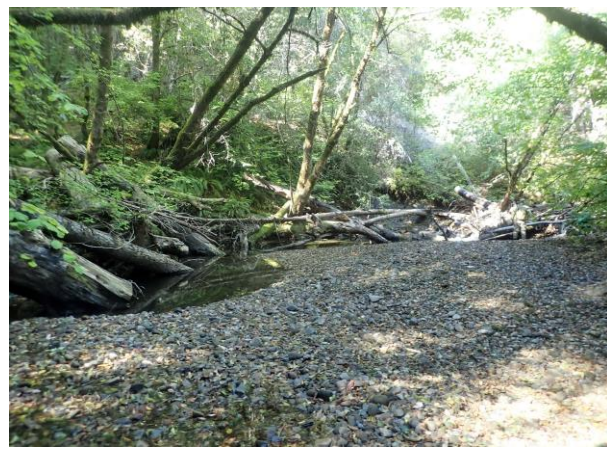
Figure 2. Large wood added by wedging in existing riparian. Resulting in increased shelter, pool depth, and habitat complexity (Post-treatment conditions, 10/01/2019)

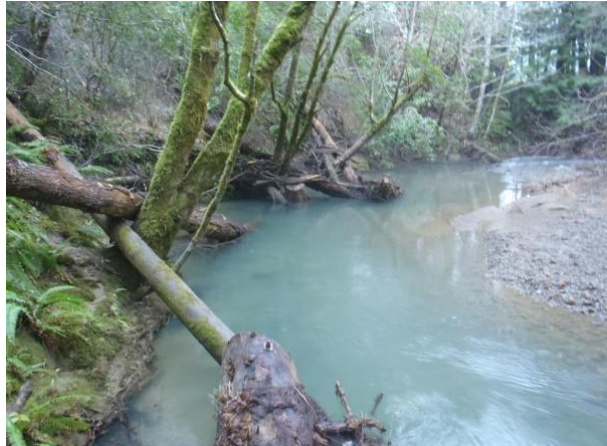
Figure 3. Two large wood features shortly after installation in lateral scour pool in lower end of treatment reach (Post-treatment conditions, 11/2/2016)

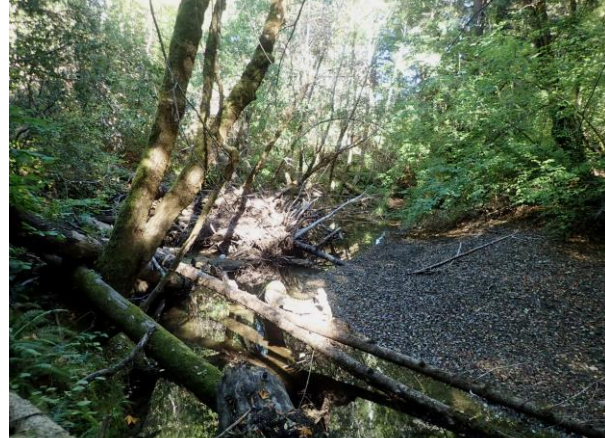
Figure 4. A significant amount of additional large wood and small woody debris was intercepted and accumulated, increasing fish cover and habitat complexity (Post-treatment conditions, 10/1/2019)
