California Department of Transportation (Caltrans) District 1 Pilot Fish Passage Assessment Study: Volume 1 – Overall Results

FHWA/CA/EN-2005/02

Final Report For Project:
F 2001 EN 10
Researching State Highway Culverts to Determine Impacts on Threatened and Endangered Salmon

February 14, 2005

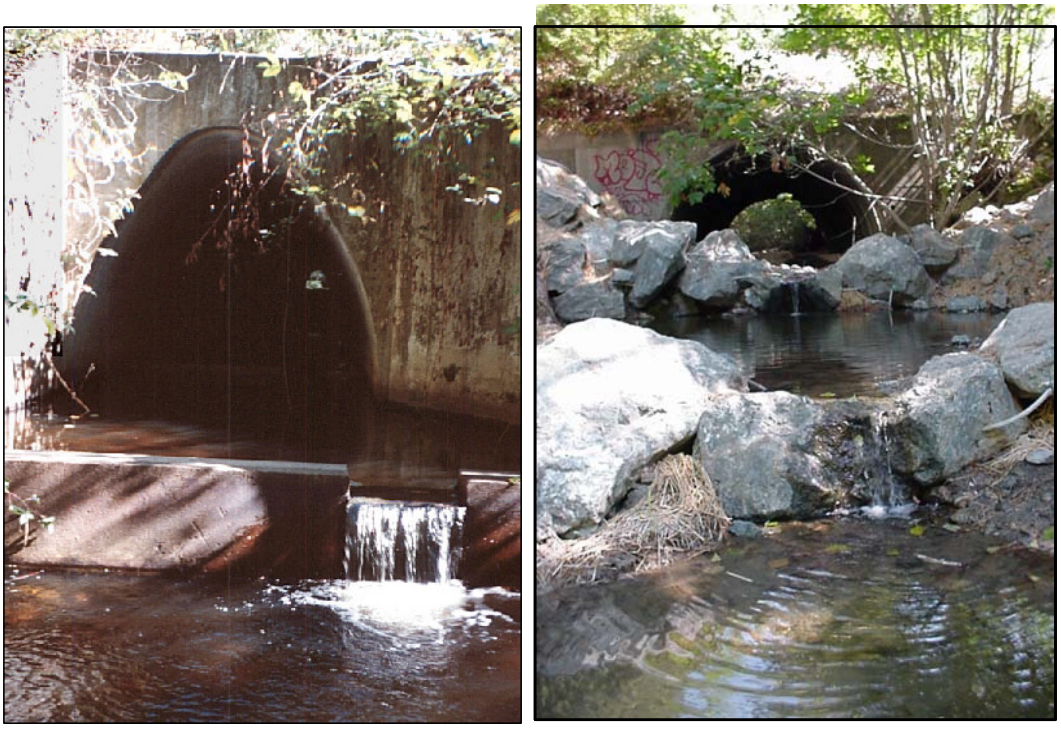
Weirs constructed of concrete or placed boulders (Figure 2.4) are common at the outlet or in the stream channel below a culvert outlet. These structures can control water levels through the culvert and may decrease velocity or outlet pool erosion. Weirs may also act as barriers to fish passage by requiring fish to leap over the weir for entry into the culvert. Fish ladders are present at a number of sites to overcome steep outlet slopes or perched outlets and allow fish access to the culvert (Figure 2.5). When fish ladders are present, a longitudinal profile of the ladder is surveyed to determine the slope, length and whether breaks in slope are present in the ladder.

Figure 2.4. The picture on the left shows a concrete outlet weir with a low flow notch. The picture on the right shows multiple boulder weirs installed to mitigate a perched outlet.

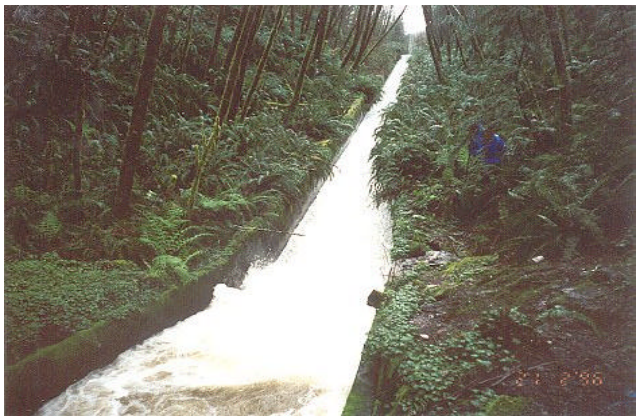
Top of concrete channel - summer flow

Complete Channel - winter flow
